3 Soil and Water Conservation Districts join forces for implementation effort

YATES COUNTY, Feb. 14, 2017 -- This past year New York State Senator Tom O'Mara assisted Yates County by providing a direct line item in the Environmental Protection Fund (EPF) to the Yates County Soil and Water Conservation District (SWCD). The funding was utilized to repair and stabilize sections of the Keuka Lake outlet and the Outlet Trail that were damaged during previous floods.

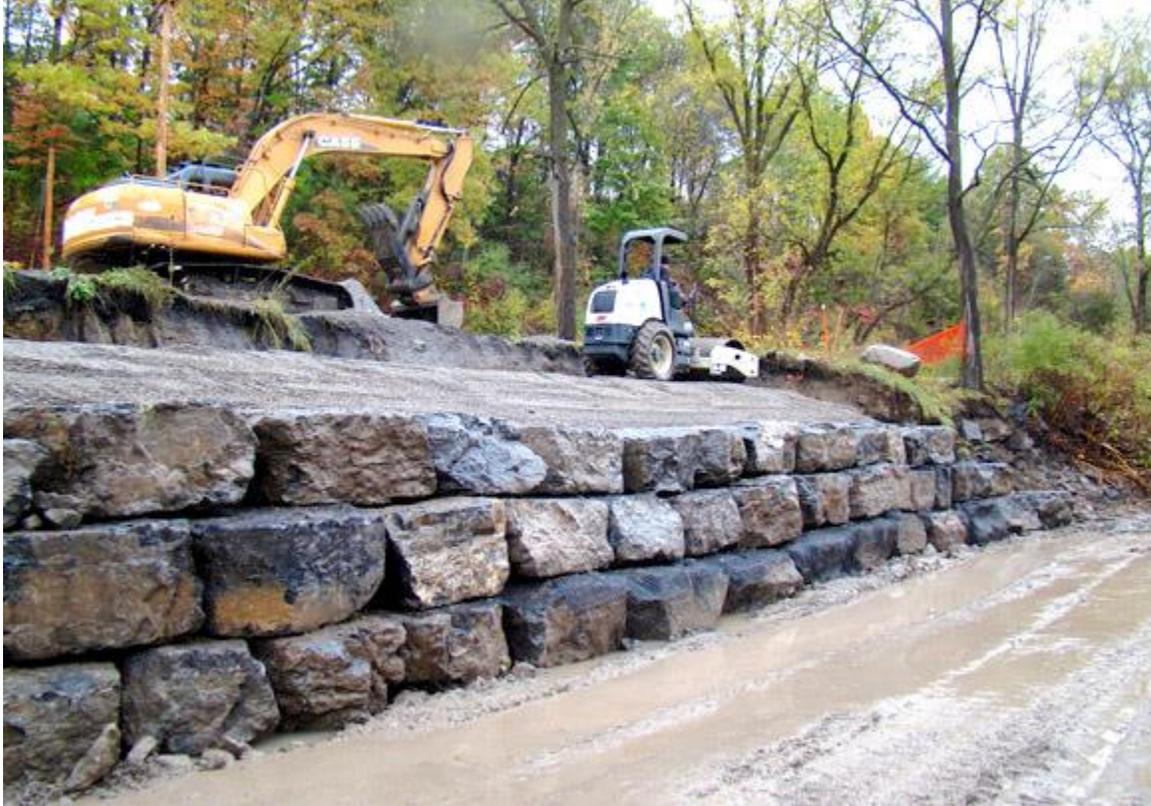
Site repair work by three conservation districts involved the use of heavy equipment and large rocks. *(Photo provided)*

The major project was to stabilize a 200-foot damaged section that included the vertical collapsed bank. The stabilization method utilized was a geo-grid rock revetment technique. This unique, state-of-the-art method has been implemented successfully several times over the last few years by the Chemung County SWCD. "Utilizing their expertise in this type of practice was a key to success of the project," said the Schuyler SWCD in a press release. The second project area stabilized 300 feet of flood-damaged stream bank. Large, dimensional rock now protects the once eroded banks, and Bendway Weirs were installed at the base of the rock to safely re-direct water flows.

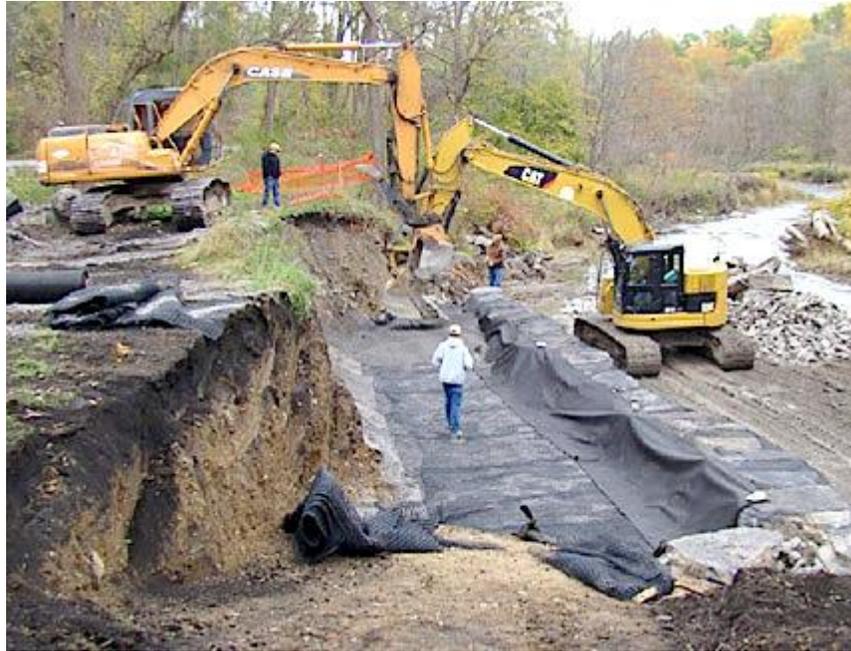
Photo in text: Workers operate machinery during the project. *(Photo provided)*

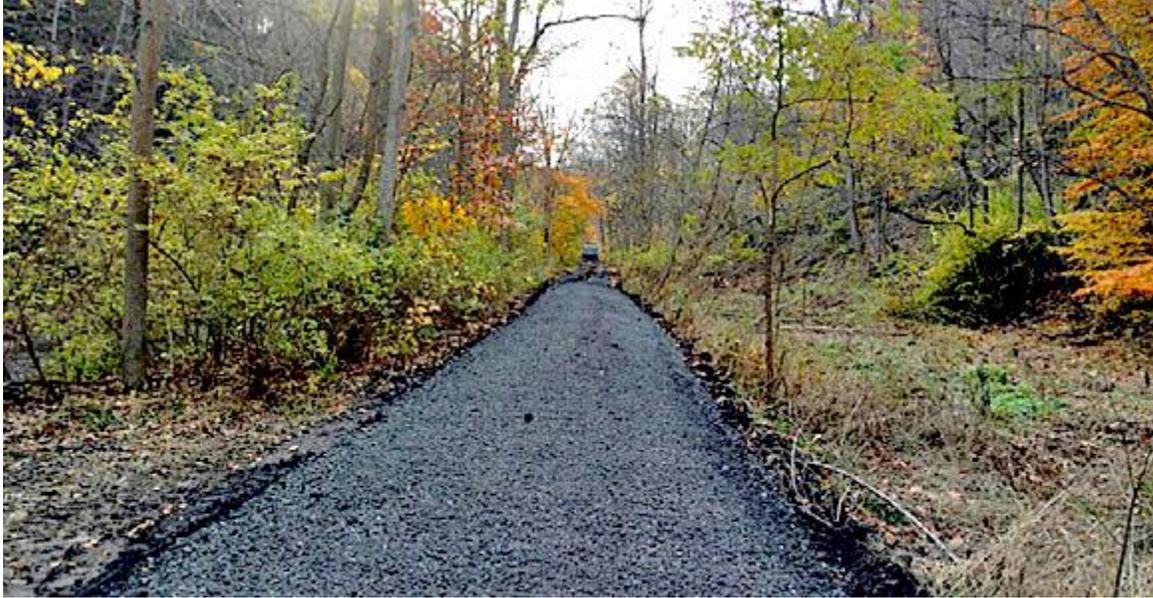
The finished outlet trail, after the coordinated effort of three conservation districts, the Town of Milo and the Highway Department. (*Photo provided*)

As the projects were nearing completion, the Town of Milo and the Highway Department provided staff and equipment to restore the Outlet Trail walking paths in the project areas.
