SWCD takes action to save resource

ALPINE, June 30, 2017 -- The Schuyler County Soil and Water Conservation District (SWCD) received a call recently notifying it of an outlet control structure failure on an expansive, 33-acre, New York State DEC wetland in the Town of Hector off of NYS Route 228, just north of the Town of Catharine line.

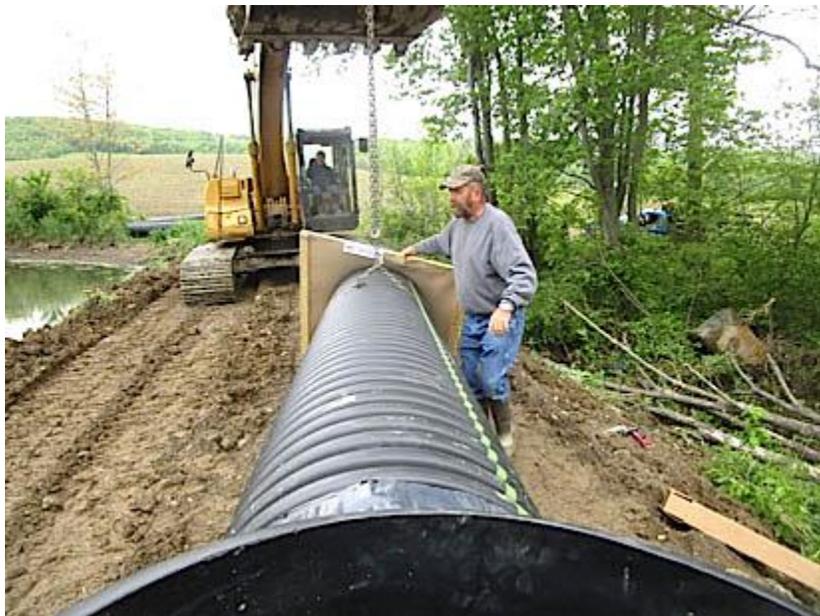
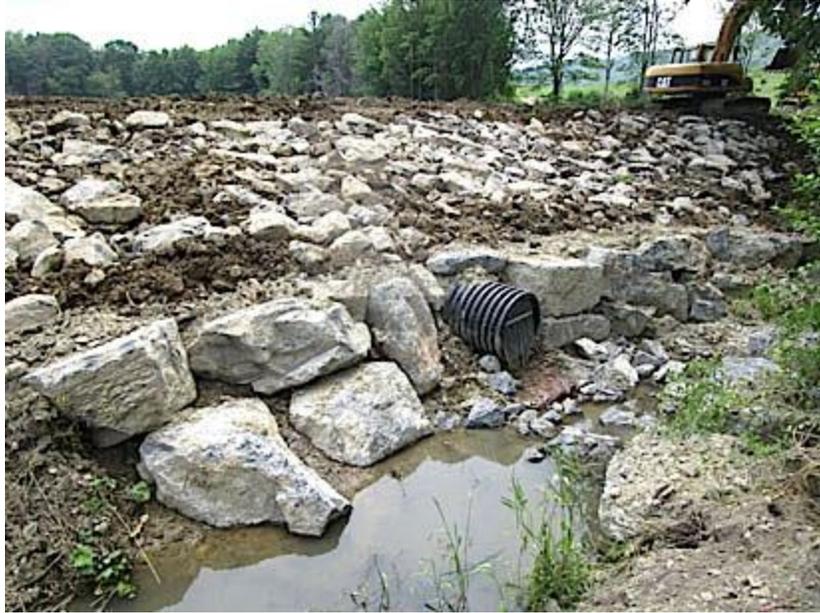
The first step was to stop the outflow of water. This was done by sealing off the failed outlet control structure with both clay and a specialized, impermeable grout type of concrete. The next step in the process was to build a coffer dam out of clay in order to open up the dike itself to install a new outlet control structure. This was completed immediately and water levels began to recover.

During inspection of the site, it was noticed that the dike itself was in very poor condition. This was due to water breaching the dike many times, as the outlet control structure had not been functioning properly for some time. It was also noticed that the earthen, emergency spillway had eroded severely and the only thing that would retain the water in the wetland (even with a functioning, primary outlet control structure) was an existing beaver dam.

Photos in text: At work on the repairs, and the finished landscape. *(Photos provided)*

So the SWCD rebuilt the dike itself, and then stabilized the emergency outlet utilizing rip rap and clay material. Over 400 tons of rip rap was used to make the repairs. With all of the rain that soon followed, it didn't take long for the wetland to fully recover.
